COLLISIONS – MATCHING THE DAMAGE

Woodrow M. Poplin, P.E.

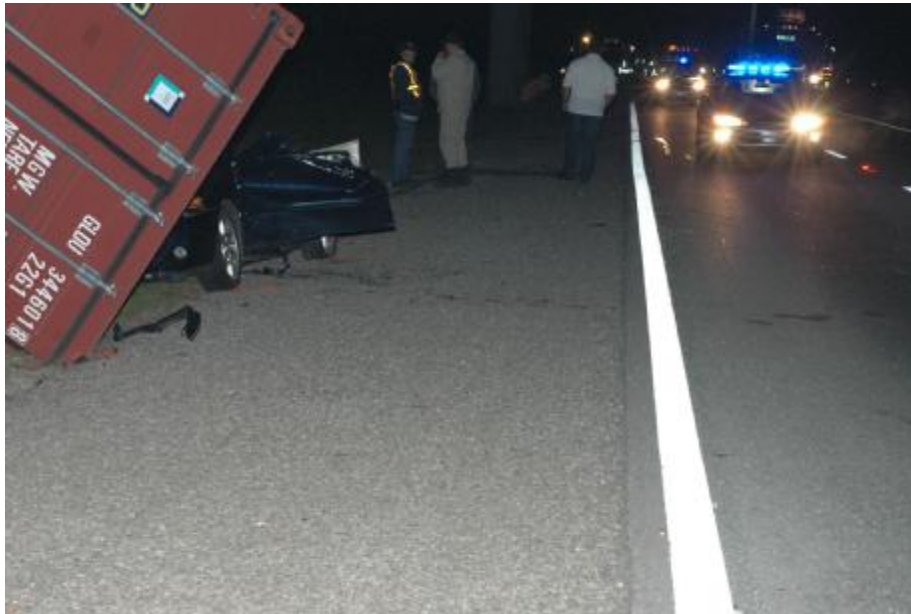
Fig. 2 Accident scene shows the highway and the vehicles off the edge of the travel lanes

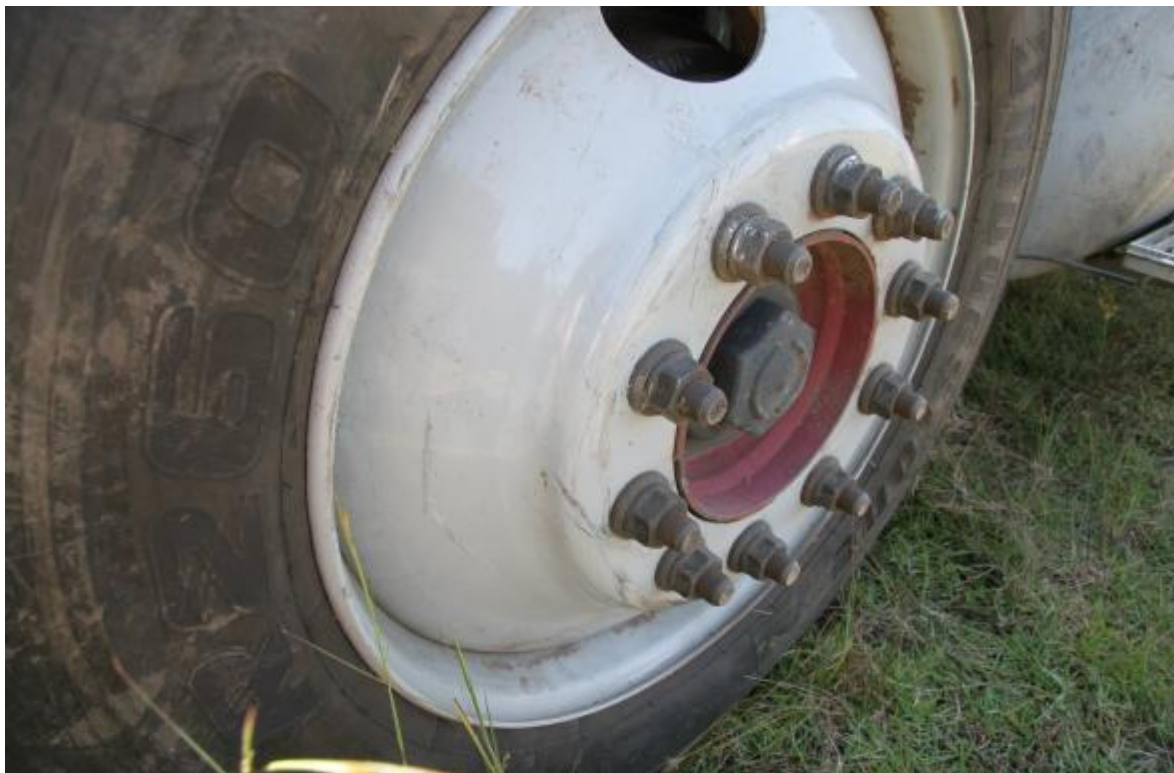
- c) **The damage at the passenger rear of the automobile was not compatible with the protruding lug nuts of a steer axle wheel. The rear fender had only scrape marks and rubber transfer from a tire.**
- d) **It was obvious that the damage at the front of the automobile was caused as the left front wheel of the truck and the passenger front of the automobile collided. The truck lug nuts protrude from the wheel and left a distinct pattern on the passenger front fender Figs. (5 - 7).**

Fig. 5 Left front wheel of the truck; note the protruding lugs

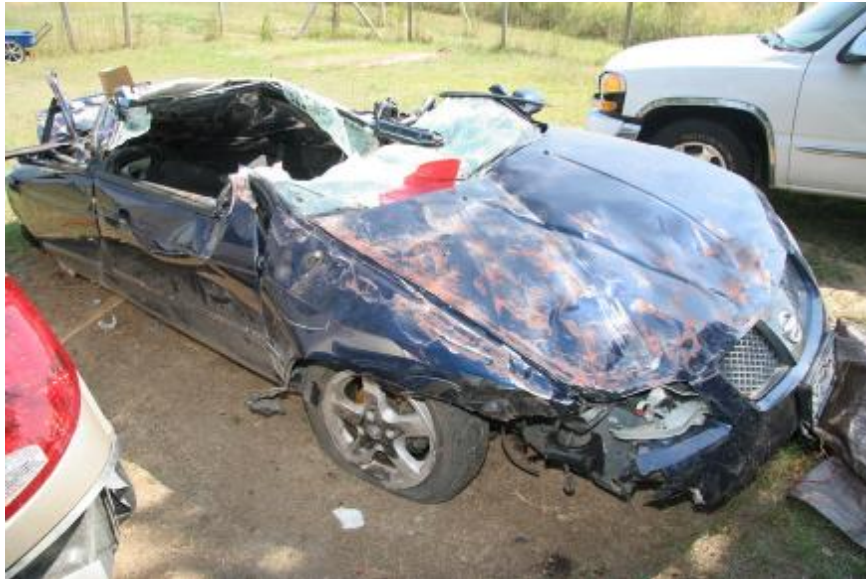
Fig. 6 Damaged automobile after it was towed from the scene

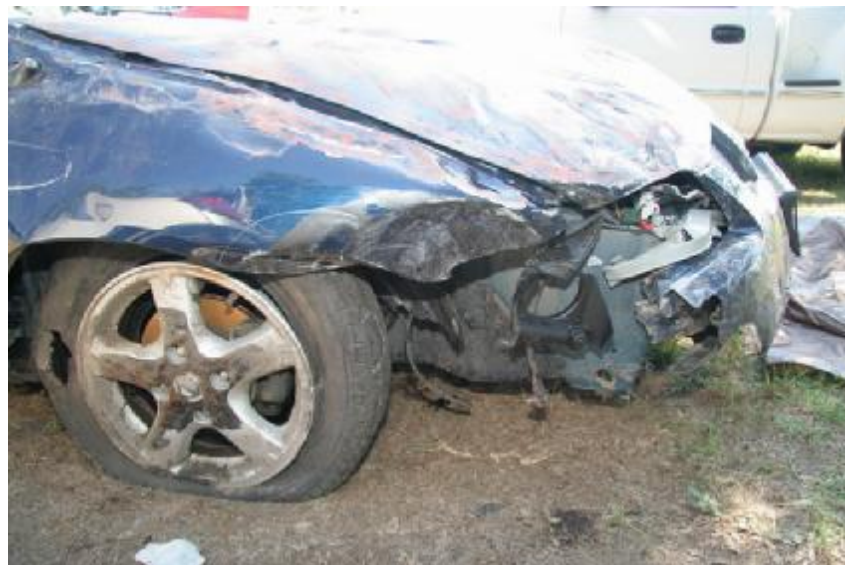
Fig. 7 Damage on the passenger front fender of the automobile

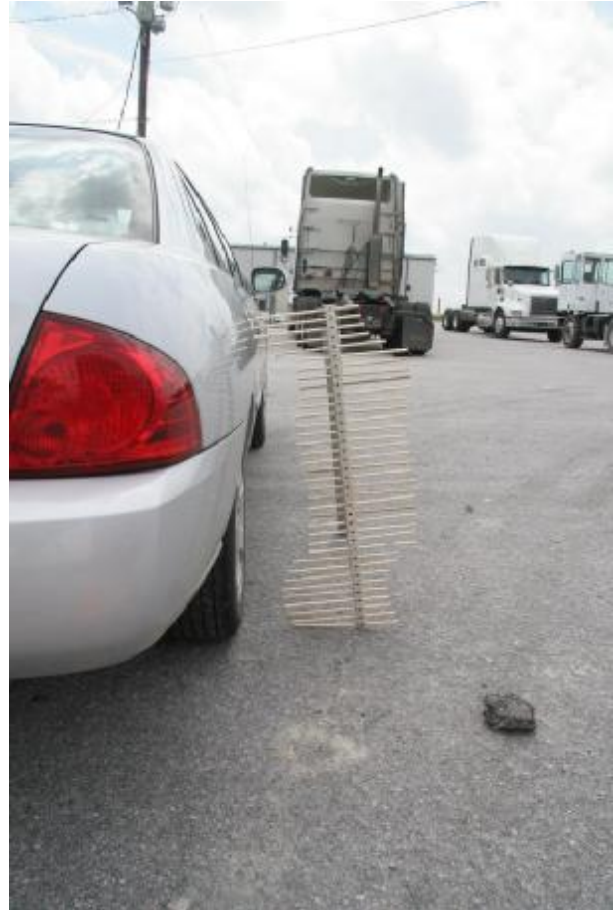
A large profile gauge was constructed using wooden dowels and perforated tubing. The “homemade” profile gauge was then matched to the side of a truck tire (Fig. 11). Using the gauge and an exemplar undamaged automobile illustrated that the contact at the passenger rear of the automobile had to have been made after the tractor-trailer had begun to overturn (Fig. 12). This eliminated the rear damage pattern as the initial contact.

Fig. 12 Matching the profile gauge to the rear fender of an exemplar automobile

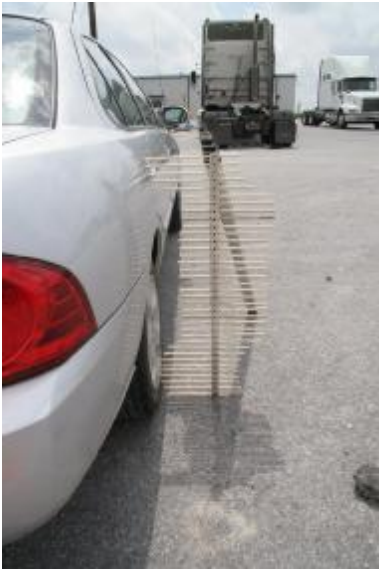
A parallel/vertical contact would have brought the truck tire into direct contact with the wheel face on the automobile. No such contact was observed. The profile of the automobile tapered inward toward the rear, but the contact overlap was greatest at the rear, opposite of what would be expected if the truck drifted left or the automobile drifted right (Figs. 13 – 14).

Fig. 13 Using the profile gauge to show the contact pattern if contact had occurred before the truck began the overturn

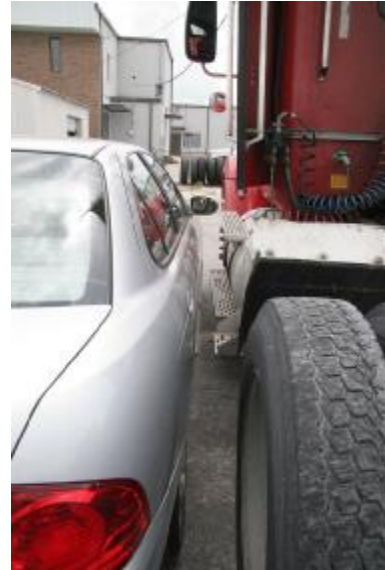
Fig. 14 Exemplar vehicles in a "sideswipe" position

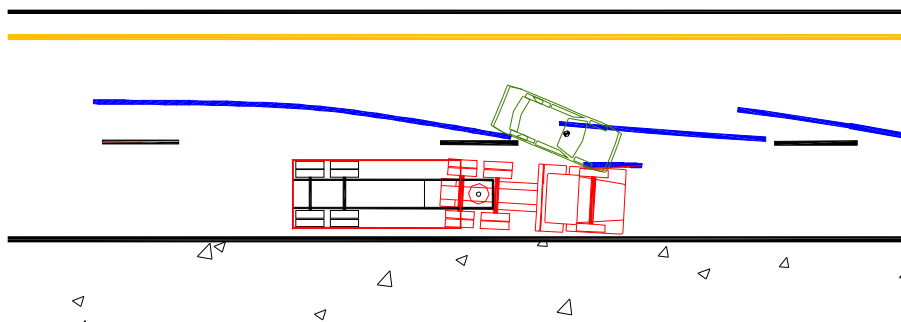
It was concluded that the initial collision resulted from a loss of control of the automobile. The automobile rotated clockwise and created a yaw mark as it traveled from the left to the right lane. The damage pattern on the passenger front of the automobile confirmed a significant angle between the vehicles at the time of the collision. The collision is illustrated in the Fig. 15.

Fig. 15 Illustration of collision position and orientation based on the tire marks and damage +
