THE RECONSTRUCTIONIST

AN ACCIDENT RECONSTRUCTION NEWSLETTER

Collisions - Matching the Damage

Woodrow M. Poplin, P.E.

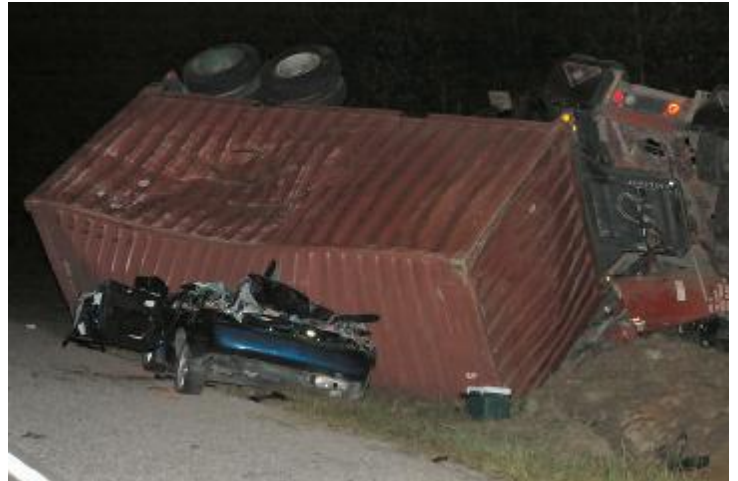
Fig. 1. Automobile and tractor trailer came to rest off the roadway

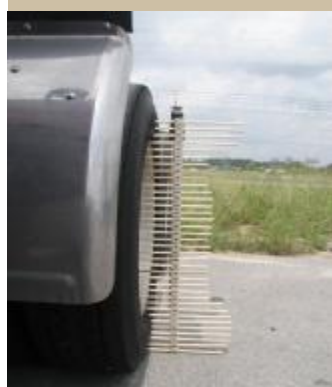
Using the gauge and an exemplar undamaged automobile illustrated that the damage profile on the side of the automobile had to have been made after the tractor-trailer had begun to overturn.

Fig. 3. Using a "homemade" profile gauge to match the truck tire

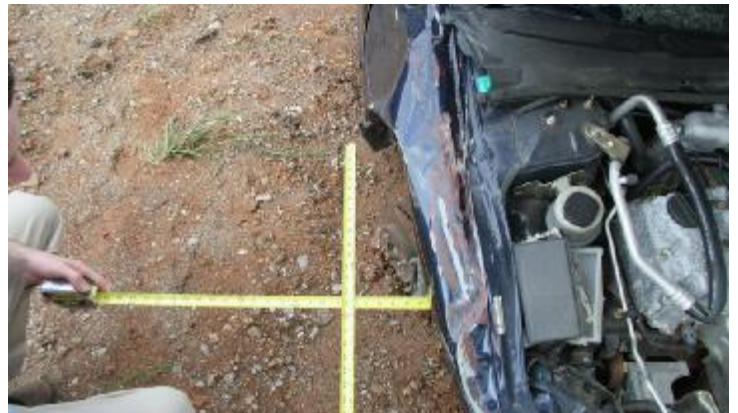
It was obvious that the damage at the front of the automobile was caused as the left front wheel of the truck and the passenger front of the automobile collided. The truck lug nuts protrude from the wheel leaving a distinct pattern on the passenger front fender and wheel of the automobile. However, the damage pattern occurred with the vehicles approximately 20° from parallel indicating that the

Fig. 2. Measuring the damage pattern on the automobile

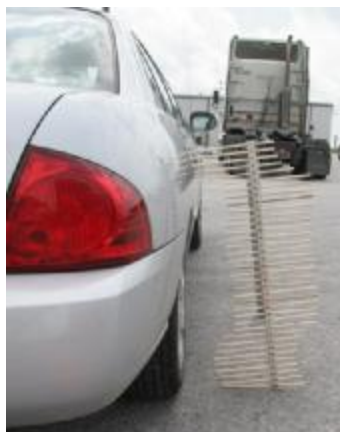
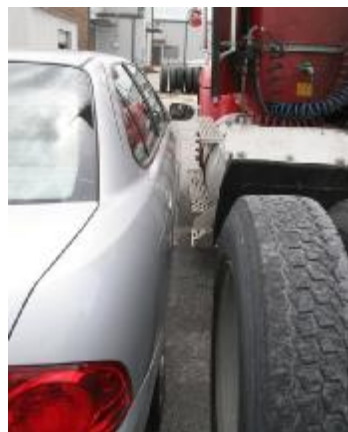
Fig. 4. Matching the profile gauge and a truck against an undamaged exemplar automobile

At issue was whether the damage at the rear occurred during an initial sideswipe contact or as the tractor-trailer began to overturn as it traveled off the roadway. A large profile gauge was constructed and matched to the side of the truck tire. Using the gauge and an exemplar undamaged automobile illustrated that the damage on the side of the automobile had to have been made after the tractor-trailer had begun to overturn. This eliminated this damage pattern as the initial contact.

It was therefore concluded that all of the collision damage occurred after the driver lost control of the automobile.
