THE RECONSTRUCTIONIST

AN ACCIDENT RECONSTRUCTION NEWSLETTER

Collisions - Matching the Damage

Woodrow M. Poplin, P.E.

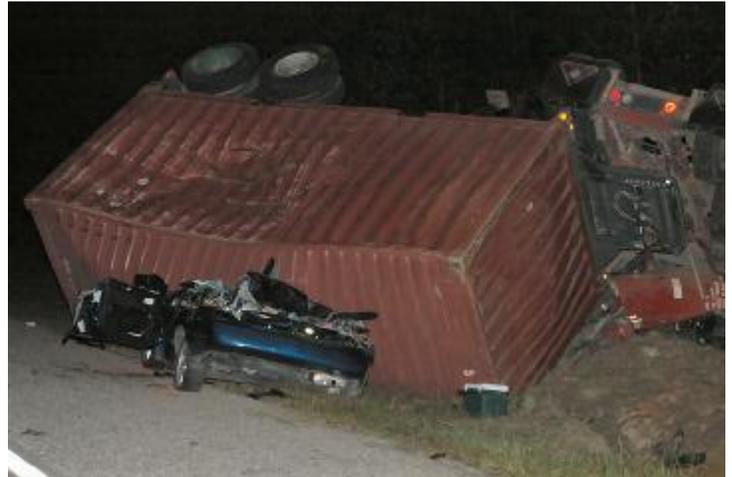
When vehicles collide, the damage patterns indicate the vehicle's position relative to each other during the collision. A recent case involved a same direction collision on an interstate highway. The passenger side of an automobile contacted the driver side tires of a tractor-trailer. There was tire contact at the passenger front and the passenger rear of the automobile. Following the collision, both vehicles swerved off the roadway to the right. The tractor-trailer rolled over the top of the automobile fatally injuring the automobile driver.

Fig. 1. Automobile and tractor trailer came to rest off the roadway

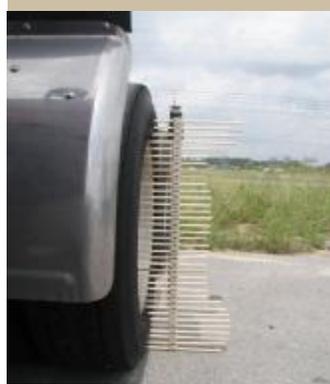
Fig. 3. Using a "homemade" profile gauge to match the truck tire

At issue was whether the damage at the rear occurred during an initial sideswipe contact or as the tractor-trailer began to overturn as it traveled off the roadway. A large profile gauge was constructed and matched to the side of the truck tire. Using the gauge and an exemplar undamaged automobile illustrated that the damage on the side of the automobile had to have been made after the tractor-trailer had begun to overturn. This eliminated this damage pattern as the initial contact.

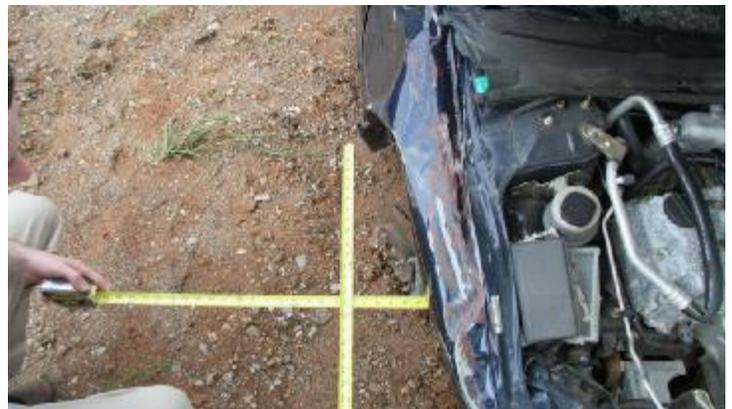
It was obvious that the damage at the front of the automobile was caused as the left front wheel of the truck and the passenger front of the automobile collided. The truck lug nuts protrude from the wheel leaving a distinct pattern on the passenger front fender and wheel of the automobile. However, the damage pattern occurred with the vehicles approximately 20° from parallel indicating that the

Fig. 2. Measuring the damage pattern on the automobile

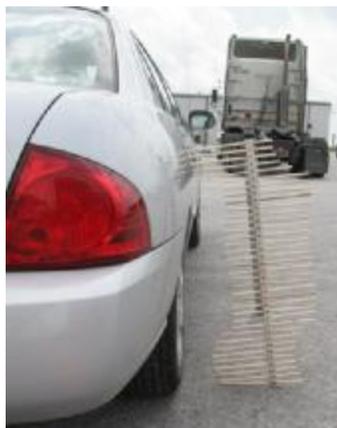
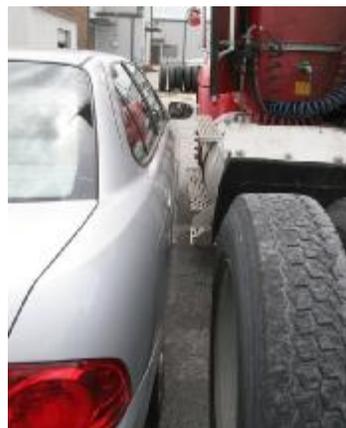
Using the gauge and an exemplar undamaged automobile illustrated that the damage profile on the side of the automobile had to have been made after the tractor-trailer had begun to overturn.

Fig. 4. Matching the profile gauge and a truck against an undamaged exemplar automobile

It was therefore concluded that all of the collision damage occurred after the driver lost control of the automobile.
