## **COLLISIONS – MATCHING THE DAMAGE**

***Woodrow M. Poplin, P.E.***

**When vehicles collide, damage is created on one or both. The damage patterns indicate the vehicle's position relative to each other during the collision. A recent case involved a nighttime same direction collision on an interstate highway.**

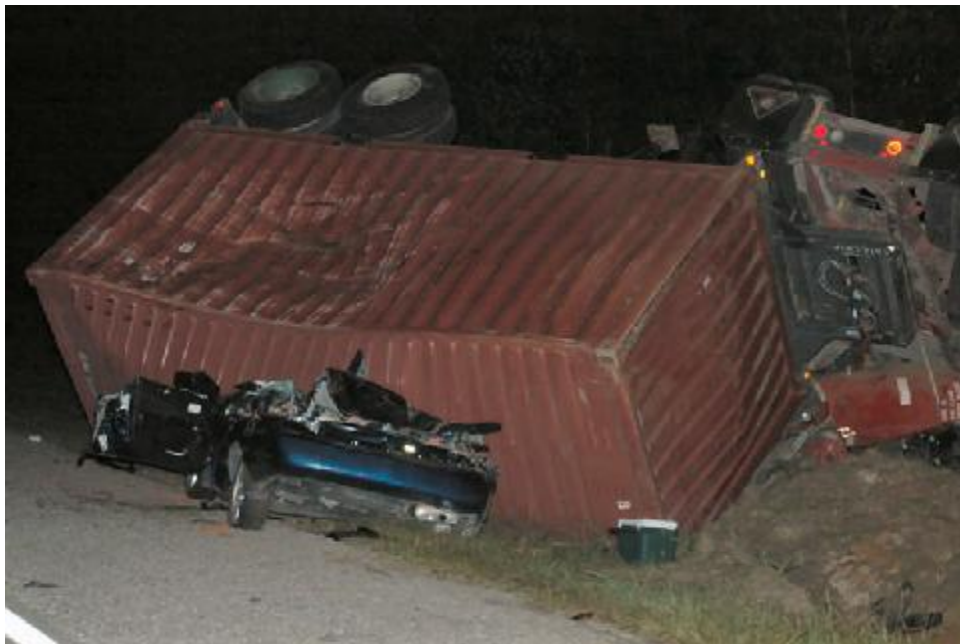
**Fig. 1 Accident scene with the overturned tractor trailer and automobile**

**The passenger side of an automobile contacted the driver side tires of a tractor-trailer. As both vehicles veered off the roadway to the right, the tractor-trailer rolled over the top of the automobile fatally injuring the automobile driver.**

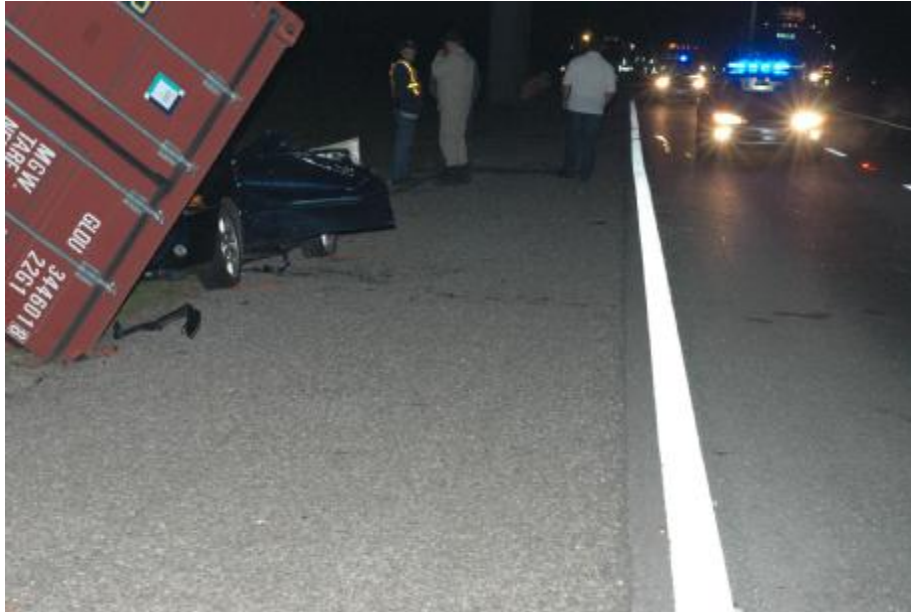
**Fig. 2 Accident scene shows the highway and the vehicles off the edge of the travel lanes**

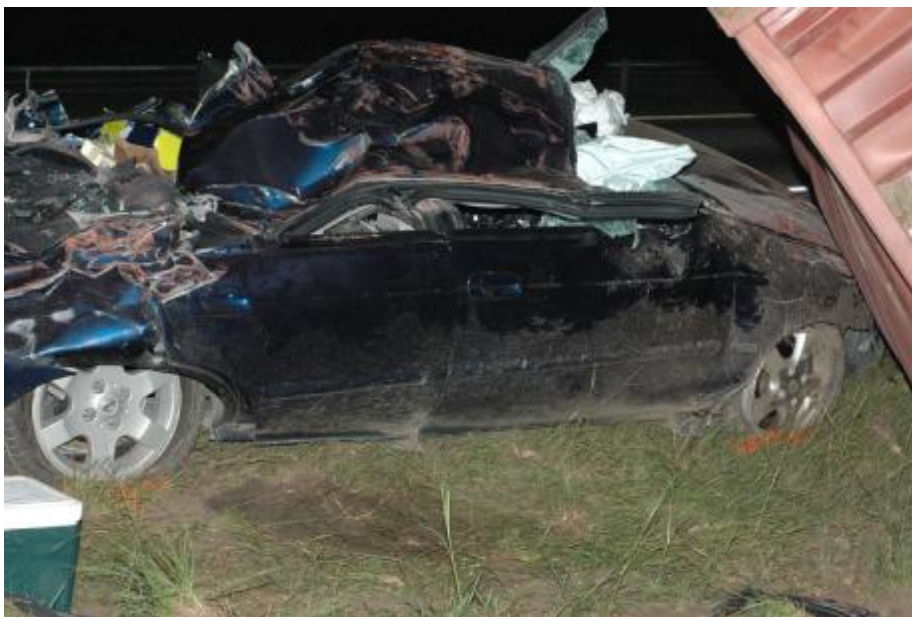
**There was extensive damage on the hood and roof of the automobile from the tractor-trailer rolling over the top. There was also damage on the passenger side of the automobile consistent with contact with a truck tire at two locations.**

**Fig. 3 Accident scene showing the passenger side of the automobile**

- (a) **passenger front fender and wheel**
- (b) **passenger rear fender**

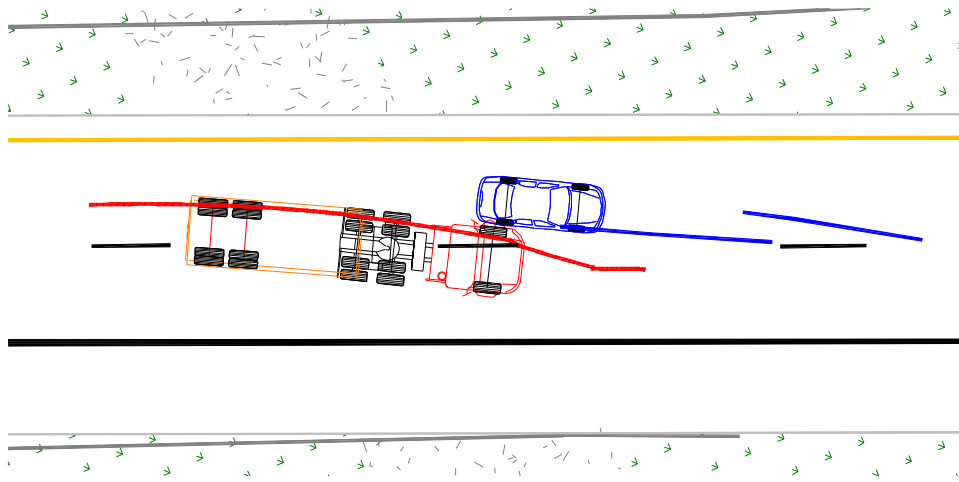
**The Highway Patrol special investigation team concluded that the truck moved left and collided with the automobile. The Highway Patrol depicted the initial collision as shown in Fig. 4.**

**Fig. 4 Illustration depicting the Highway Patrol special investigation depiction of the initial collision**

- a) **The tire mark patterns on the roadway were incompatible with the Highway Patrol collision sequence.**
- b) **The Highway Patrol depicted a collision position that would create contact between the truck's front bumper and the side of the automobile. There was no evidence of the bumper contact on the end of the bumper or on the side of the automobile.**

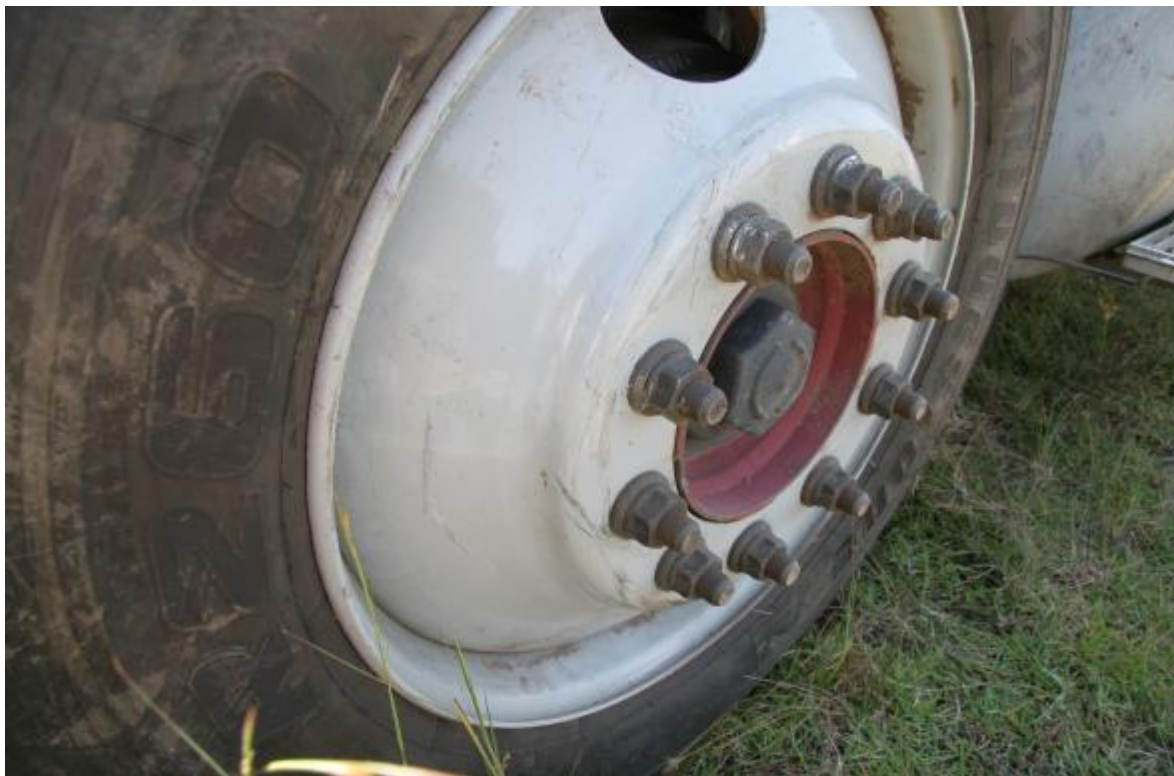
- c) **The damage at the passenger rear of the automobile was not compatible with the protruding lug nuts of a steer axle wheel. The rear fender had only scrape marks and rubber transfer from a tire.**
- d) **It was obvious that the damage at the front of the automobile was caused as the left front wheel of the truck and the passenger front of the automobile collided. The truck lug nuts protrude from the wheel and left a distinct pattern on the passenger front fender Figs. (5 - 7).**

**Fig. 5 Left front wheel of the truck; note the protruding lugs**

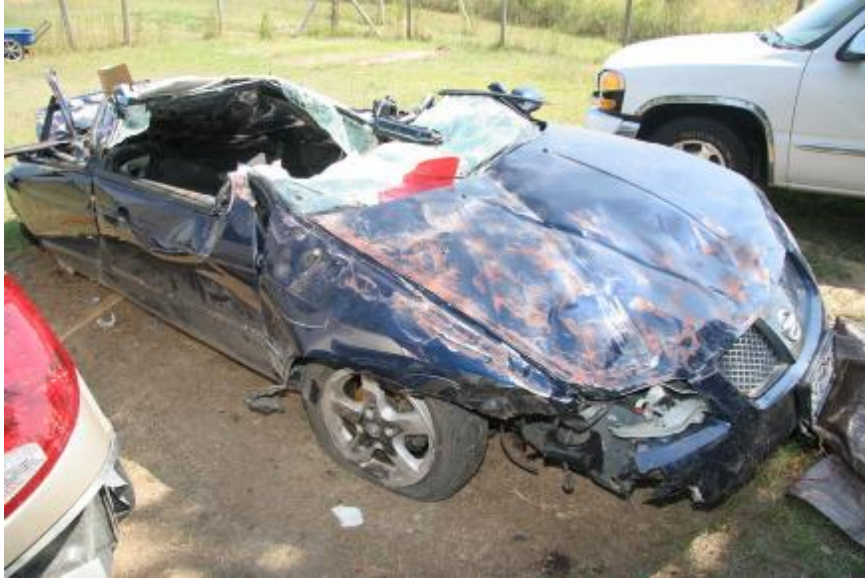
**Fig. 6 Damaged automobile after it was towed from the scene**

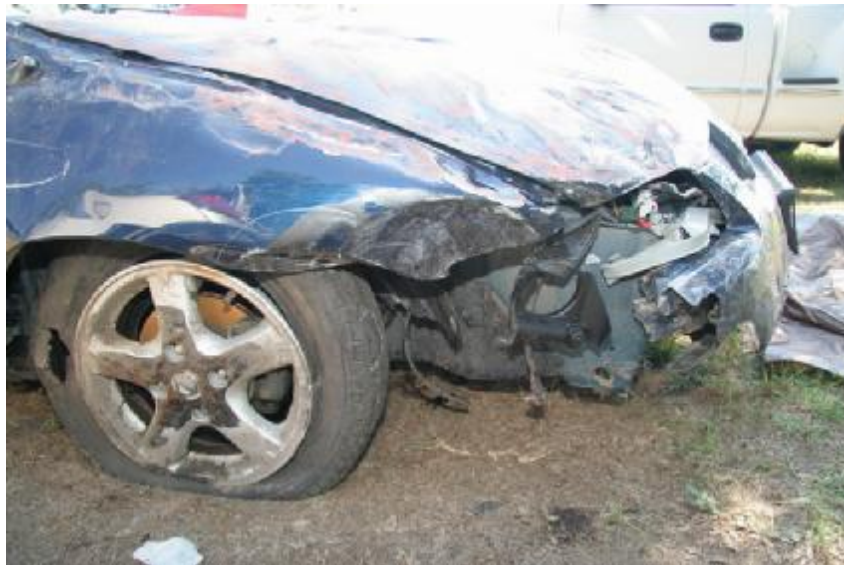
**Fig. 7 Damage on the passenger front fender of the automobile**

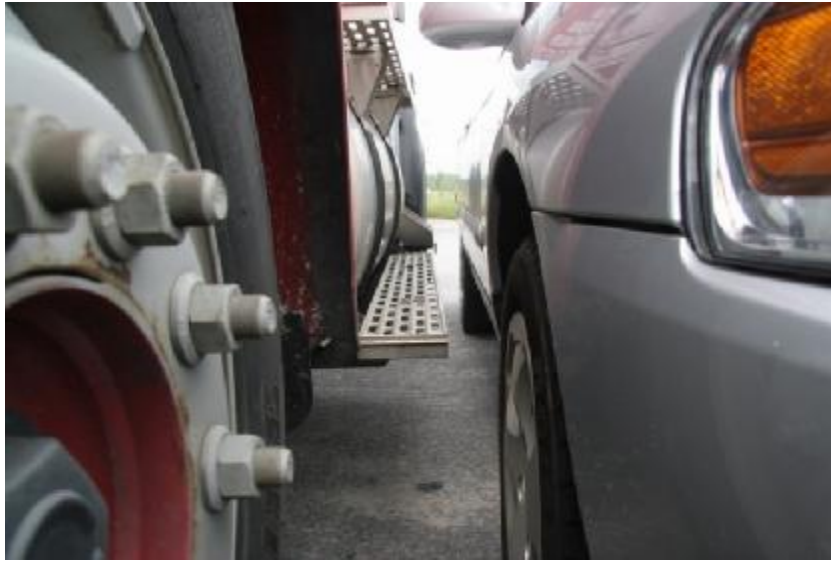
**With the vehicles relatively parallel, contact at the right rear of the automobile by either drive axle of the tractor would have produced damage on the side of the automobile from the truck steps (Fig. 8). No damage from the steps is observed on the automobile nor was there any damage to the steps of the tractor.**

**Fig. 8 Exemplar vehicles positioned in a "sideswipe" configuration**

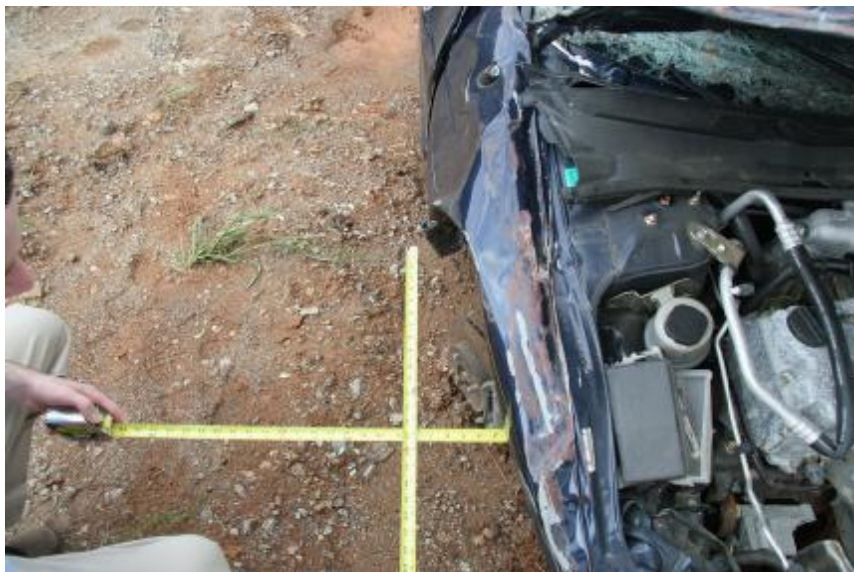
Measuring the damage pattern on the passenger front fender showed that the contact occurred with the vehicles approximately 20° away from parallel (Fig. 9). A normal "sideswipe" would be very close to parallel. The significant angle indicated that the automobile was already "out of control" when this damage occurred. This conclusion was also consistent with the tire mark patterns observed on the roadway.

**Fig. 9 Measuring the damage at the passenger front of the automobile**

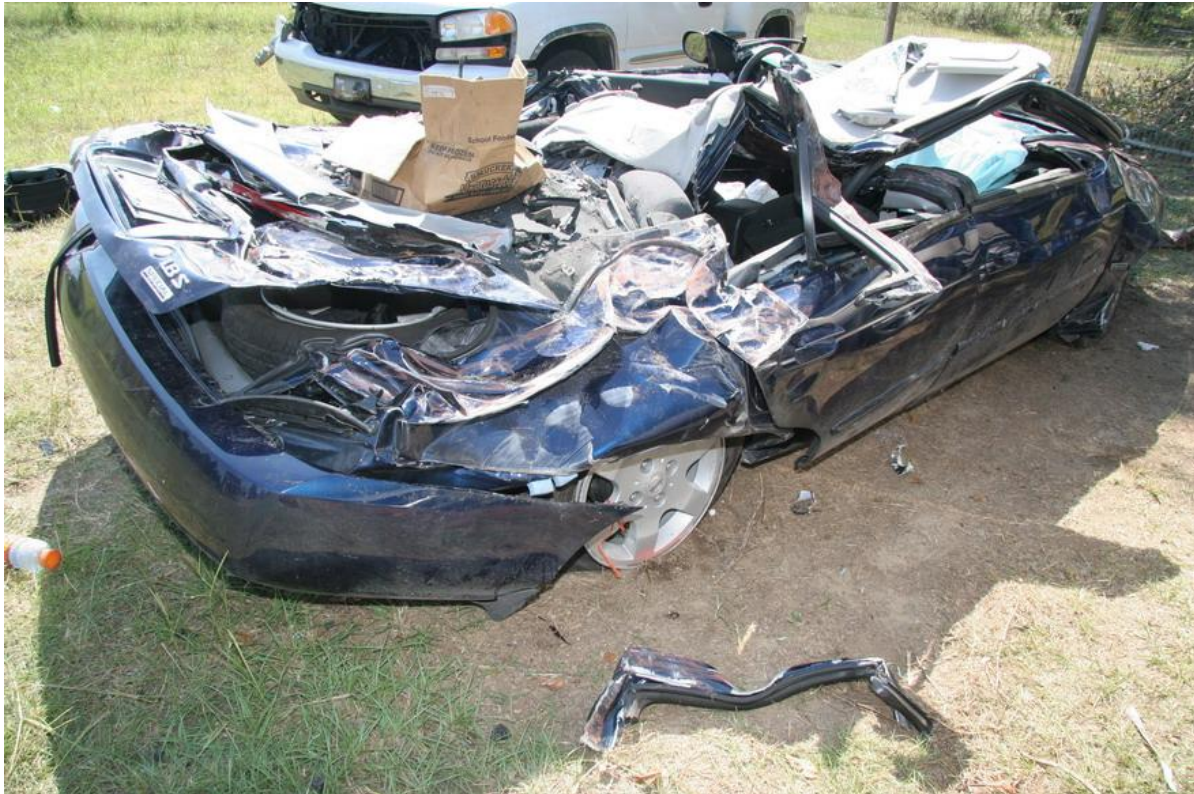
**The remaining issue was whether the damage at the rear (Fig. 10) occurred during an initial sideswipe contact or as the tractor-trailer began to overturn as it veered off the roadway.**

**Fig. 10 Passenger rear fender of automobile**

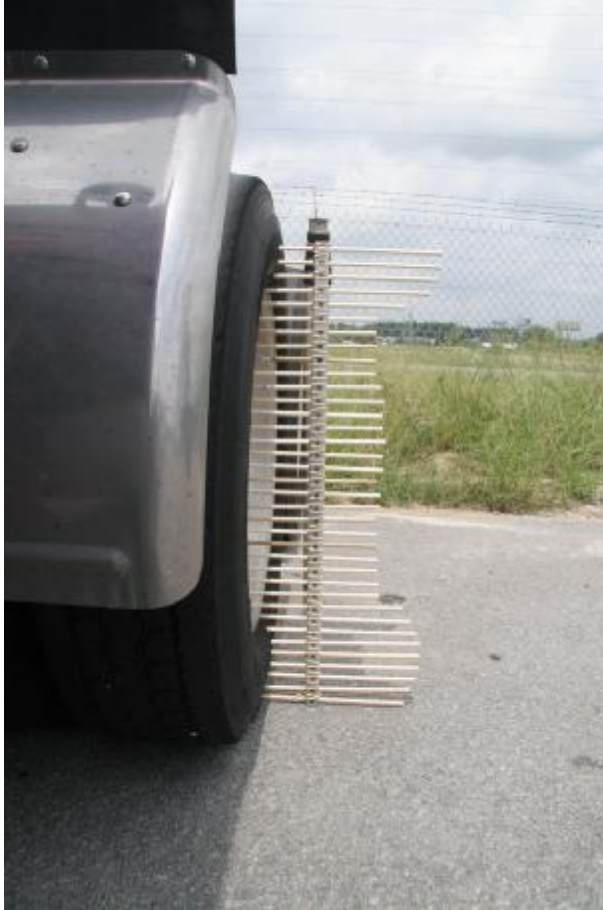
**A large profile gauge was constructed using wooden dowels and perforated tubing. The “homemade” profile gauge was then matched to the side of a truck tire (Fig. 11). Using the gauge and an exemplar undamaged automobile illustrated that the contact at the passenger rear of the automobile had to have been made after the tractor-trailer had begun to overturn (Fig. 12). This eliminated the rear damage pattern as the initial contact.**

**Fig. 11 Matching a "homemade" profile gauge to a truck tire**

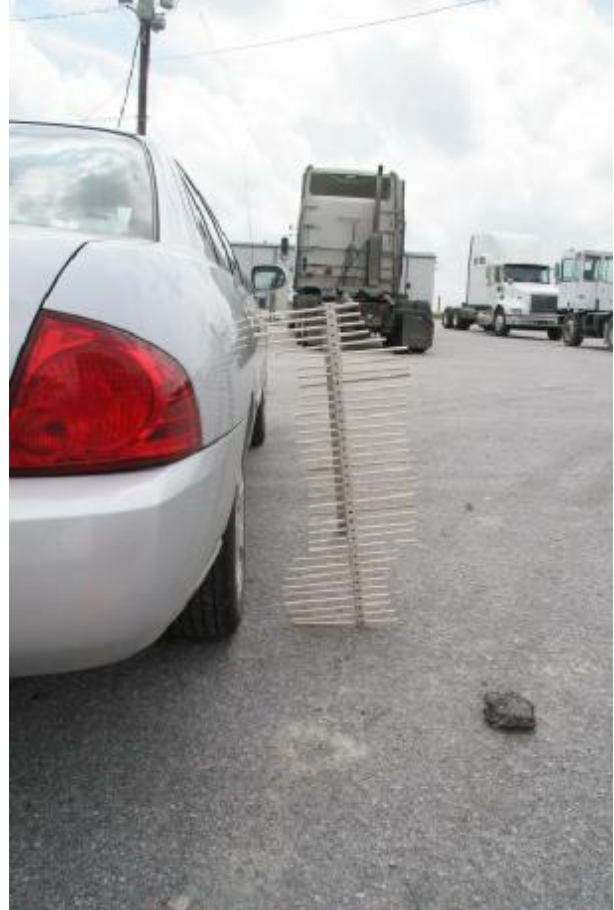
**Fig. 12 Matching the profile gauge to the rear fender of an exemplar automobile**

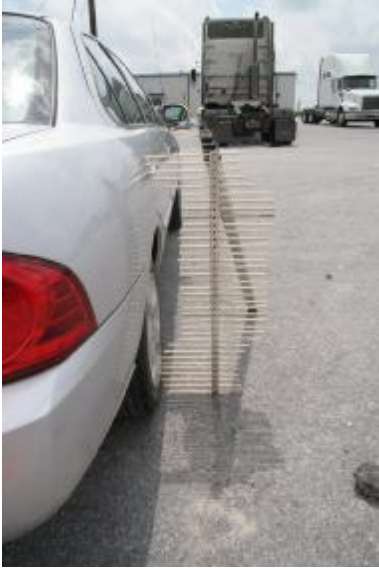
**A parallel/vertical contact would have brought the truck tire into direct contact with the wheel face on the automobile. No such contact was observed. The profile of the automobile tapered inward toward the rear, but the contact overlap was greatest at the rear, opposite of what would be expected if the truck drifted left or the automobile drifted right (Figs. 13 – 14).**

**Fig. 13 Using the profile gauge to show the contact pattern if contact had occurred before the truck began the overturn**

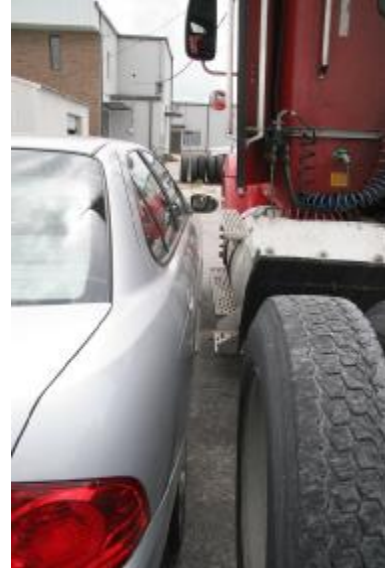
**Fig. 14 Exemplar vehicles in a "sideswipe" position**

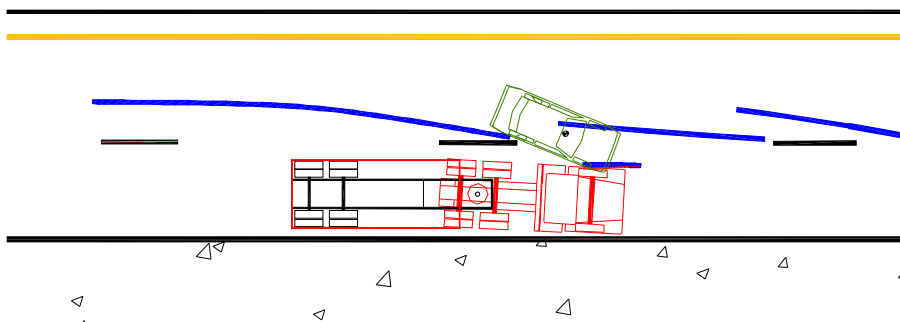
It was concluded that the initial collision resulted from a loss of control of the automobile. The automobile rotated clockwise and created a yaw mark as it traveled from the left to the right lane. The damage pattern on the passenger front of the automobile confirmed a significant angle between the vehicles at the time of the collision. The collision is illustrated in the Fig. 15.

**Fig. 15 Illustration of collision position and orientation based on the tire marks and damage +**

**The primary collision "steered" the truck abruptly to the right and initiated the overturn. The damage on the rear render of the automobile occurred just before the tractor trailer overturned onto the automobile. There was no evidence that the tractor trailer had ever moved out of the right lane.**
