W Poplin Engineering

COLLISIONS - Matching The Damage

At issue - Did the tractor trailer move left and sideswipe the automobile or did the automobile driver lose control and move right into the tractor trailer?

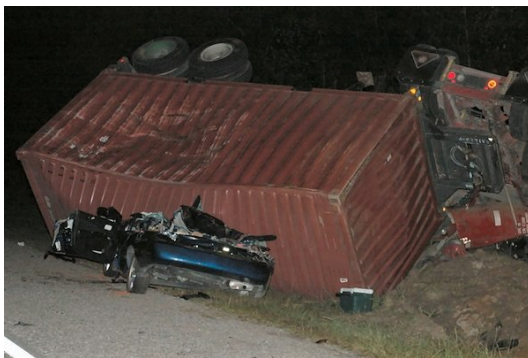
Accident Scene - Possible Side Swipe Collision?

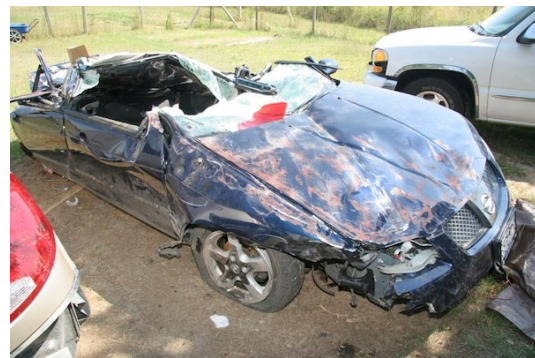
Damaged Automobile after it was Towed

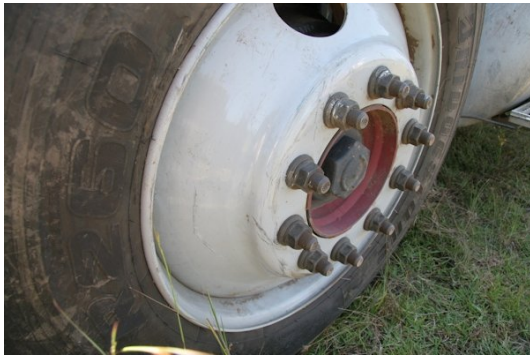
Left Front Wheel - Truck Lug Pattern was Found on Car Passenger Front Fender

It was obvious that the damage at the front of the automobile was caused as the left front wheel of the truck and the passenger front of the automobile collided. The truck lug nuts protrude from the wheel leaving a distinct pattern on the passenger front fender and wheel of the automobile. However, the damage pattern occurred with the vehicles approximately 20° from parallel indicating that the automobile was already "out of control" when this contact occurred.

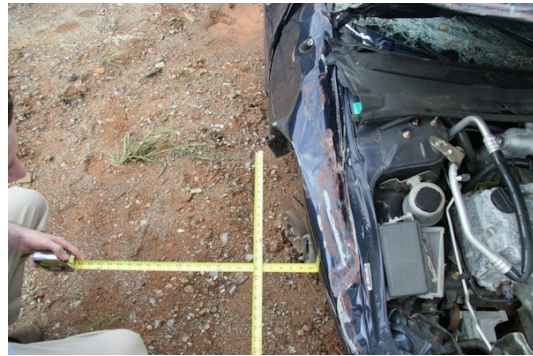
Measuring the Lug Damage Pattern - 20° from parallel

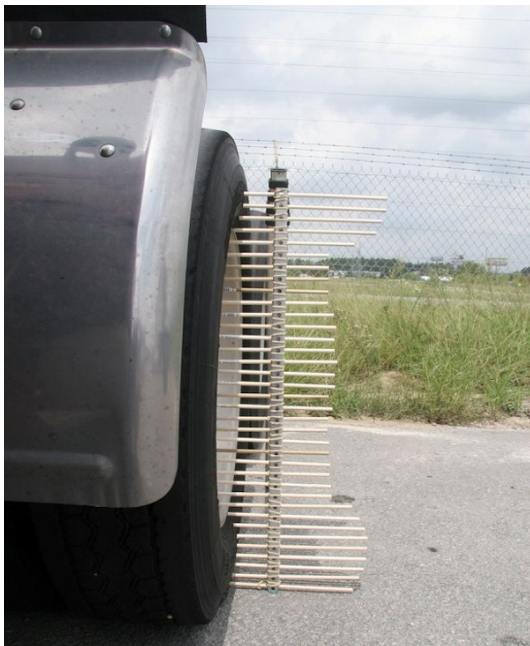
Using a "Homemade" Profile Gauge to Match the Truck Tire

A large profile gauge was constructed and matched to the side of the truck tire. Using the gauge and an exemplar undamaged automobile illustrated that the damage to the rear

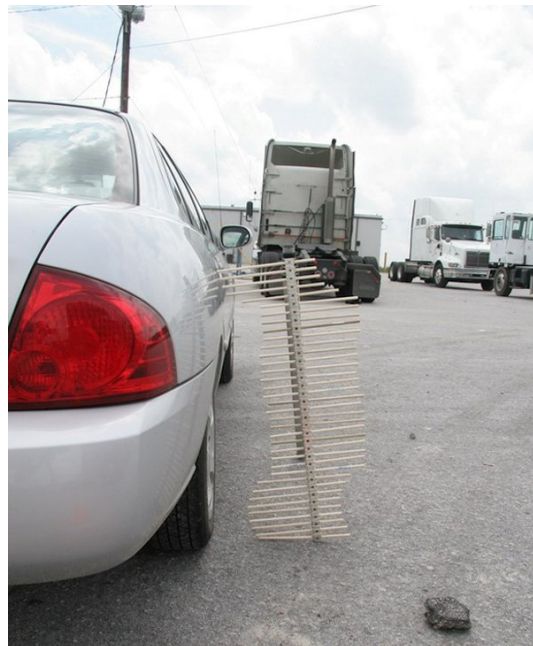
Matching the Profile Gauge To the Fender - Confirming Overturn not Sideswipe

fender of the automobile had to have been made after the tractor-trailer had begun to overturn. There was no damage on the truck nor the automobile that was consistent with a sideswipe contact.

It was therefore concluded that all of the collision damage occurred after the automobile driver lost control and traveled into the adjacent lane colliding with the tractor trailer.
